Manhole Inspection Summary

Manhole # S21GG1007MH

Location Address: **1620 41ST ST**

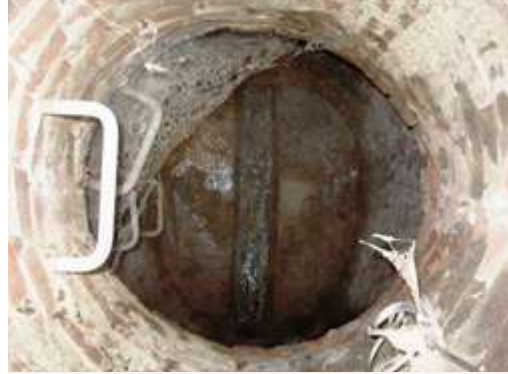
Top View

Evidence of surcharge - Bench debris.

Subject to ponding

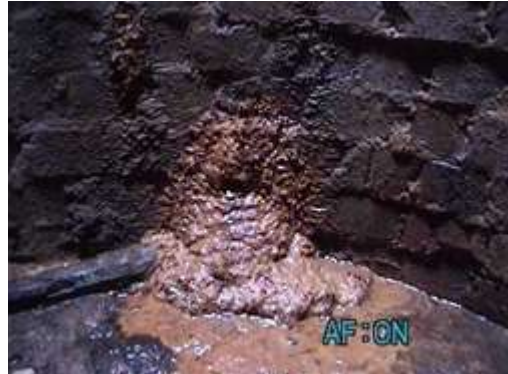
Defect

Frame leaks. Adjustment deterioration, loose brick and infiltration. Corbel and Barrel infiltration.

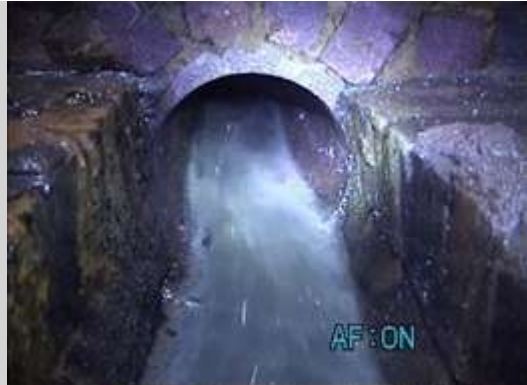
8 in. Circular Gravity Sewer Pipe Out @ 12 O'Clock

Rod and Bar (Angled)

Infiltration: **None** Pipe Seal Cond: **Unknown**

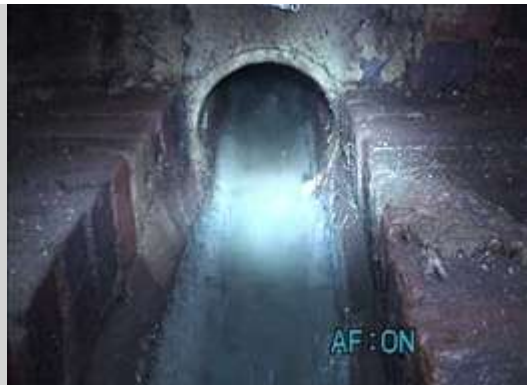
8 in. Circular Gravity Sewer Pipe In @ 6 O'Clock

Rod and Bar (Angled)

Infiltration: **None** Pipe Seal Cond: **Unknown**
